B. Wastes, tailing ponds, and route of wastes

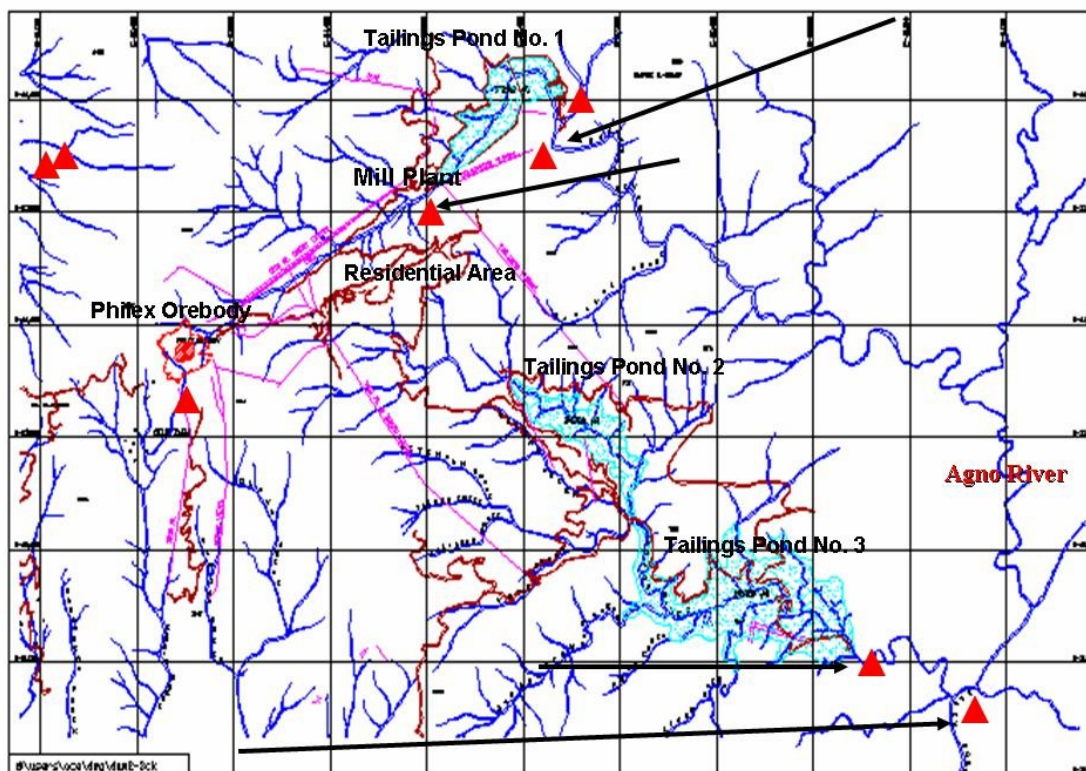
Figure 41. Map on Philex ore body, mill, residential areas, and tailing ponds

Based on the location of Philex tailing pond 2 on Figure 41 above and Google earth picture on Figure 42, tailing pond 2 is approximately in the vicinity of $16^{\circ}15'16.62$ North and $120^{\circ}39'43.84''$ East. Finally, based on Figure 41 and Google Earth image on Figure 42, Philex tailings pond 3 is approximately in the vicinity of $16^{\circ}14'31.34$ North and $120^{\circ}40'45.48''$ East.

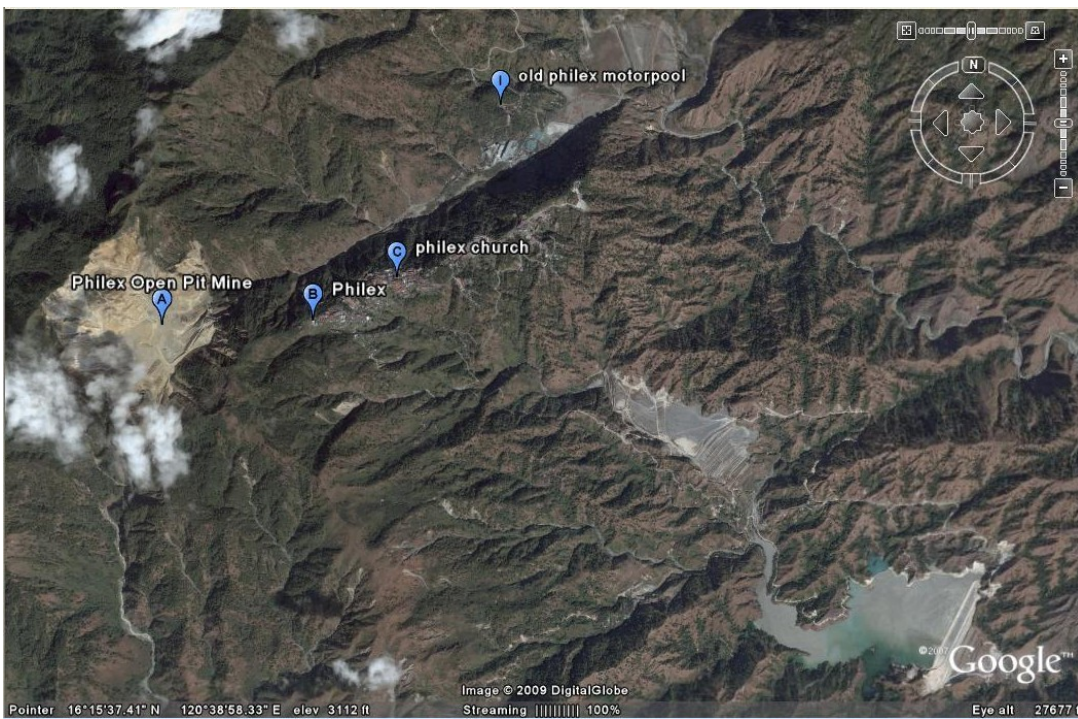
Figure 42. Philex open pit mine, tailing ponds, and nearby areas on Google Earth (labels are from Google Earth and not by the author of this work)

Analyzing Figure 42 page 33, the earth position of the Philex ore body/open pit mine is approximately in the vicinity of $16^{\circ}15'45.62''$ North $120^{\circ}37'18.87''$ East. Based on the shape of Philex tailing pond 1 on Figures 43 and 47, pages 33 and 35, as well as Google Earth picture on Figure 42, Philex tailings pond 1 is approximately in the vicinity of $16^{\circ}15'53.08''$ North and $120^{\circ}39'16.79''$ East.

Figure 42 indicates that tailing ponds 2 and 3 are connected and Figure 45 page 34 indicate that both tailing ponds ultimately discharge into the Ago River. As early as 2001, the Department of Environment and Natural Resources-Cordillera (DENR-CAR) has already identified the three tailing ponds of Philex Mining Company as among the seven geo-hazards of mining in the region of the Cordillera, Philippines.

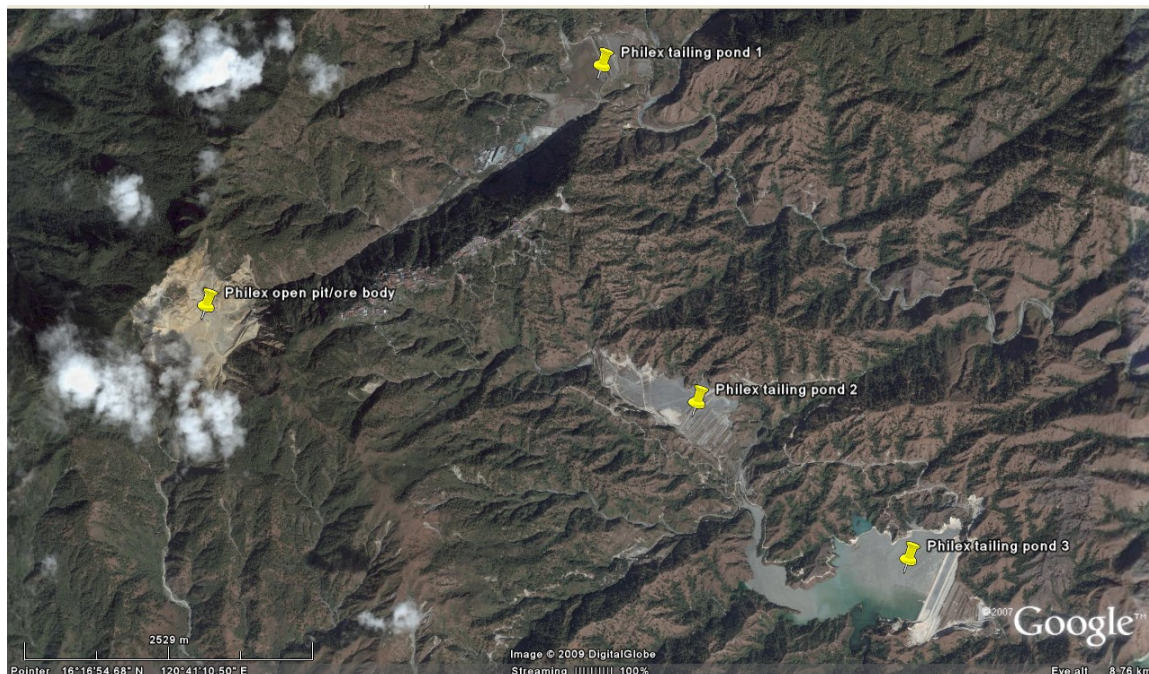
Figure 44. Philex open pit/ore body (Sto. Tomas II) and tailing ponds 1, 2, and 3

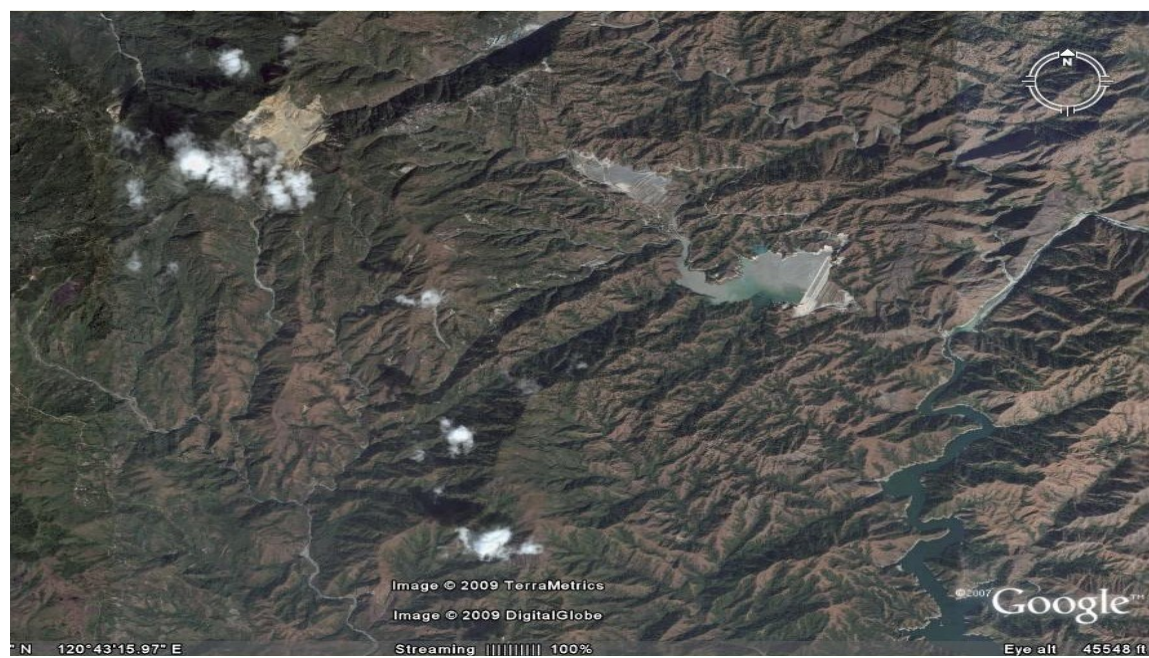
Figure 45. Philex tailing ponds 1, 2, and 3 and link to body of water (Agno River)

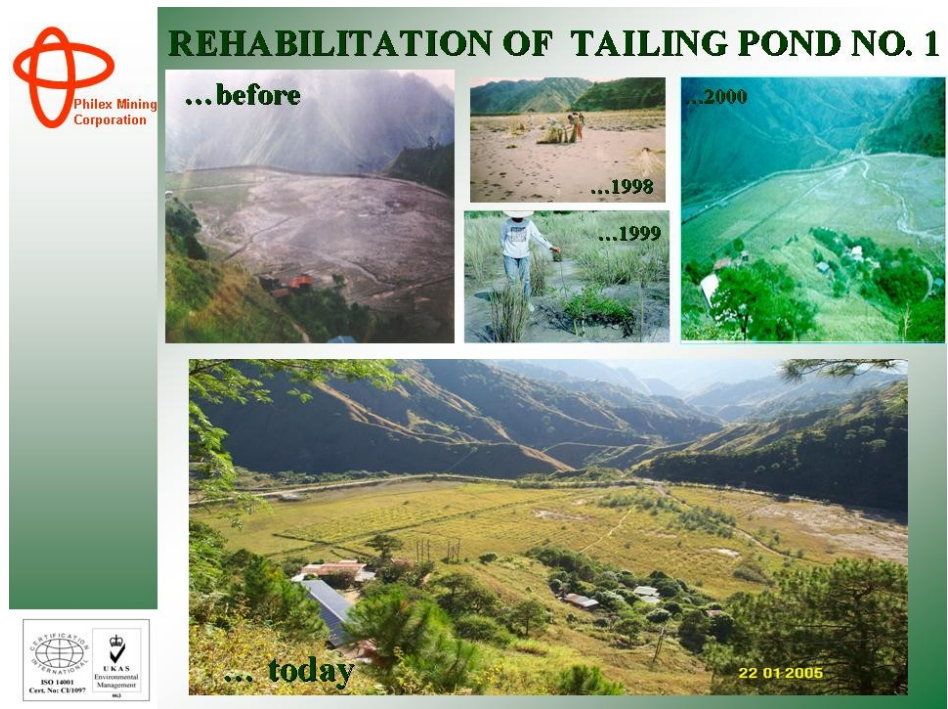
Figure 46. Philex tailings pond 1 then and now (26 hectares, expected useful life was 10 years, closed in 1981)
