Table . Philex tailings pond, expected useful life, area, capacity, and status

Figure 48. Mine waste management in tailings pond 3

Figure 49. Tailings pond 3 is reported by Philex as its “active tailing pond”

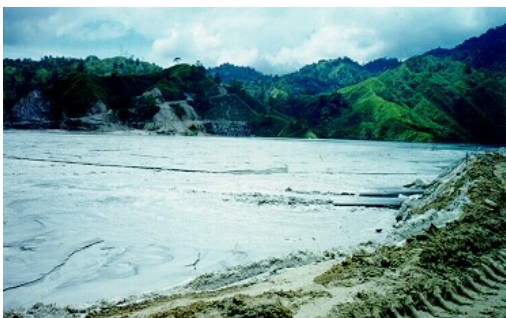
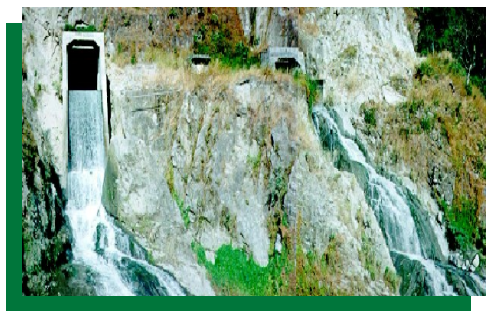
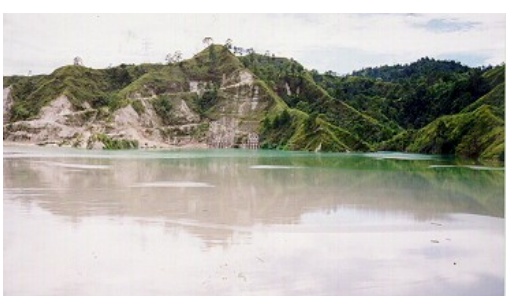
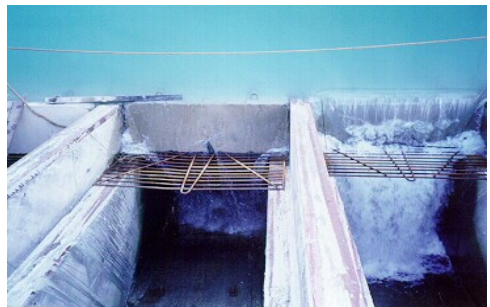
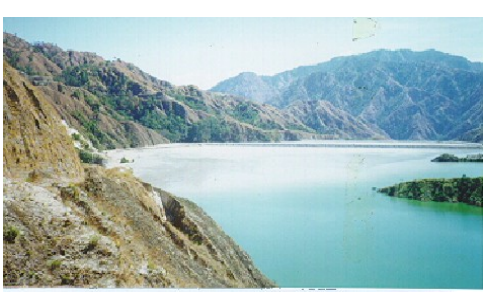
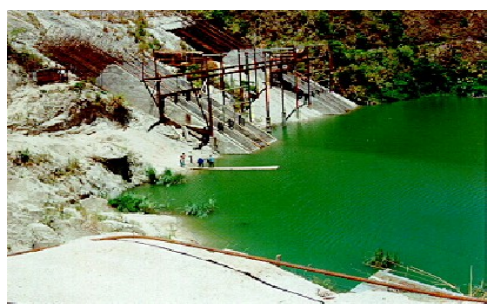
TAILINGS CONVEYED VIA PIPELINE FROM TAILINGS TUNNEL

TAILINGS DEPOSITED IN POND

DECANT WATER FLOWS THROUGH DECANT TUNNEL

SEDIMENT SETTLES & CLEAR WATER FLOWS TOWARDS PENSTOCK

DECANTATION TAKES PLACE

The illustration above from Philex itself describes how mine tailings are managed in tailings pond 3. Obviously, some of the environmental risks that can be associated with Philex tailings pond 3 are the dissolved chemicals and heavy metals in the effluents from the tailing pond as well as the chemicals and heavy metals from the mine tailings deposited in the tailing pond.

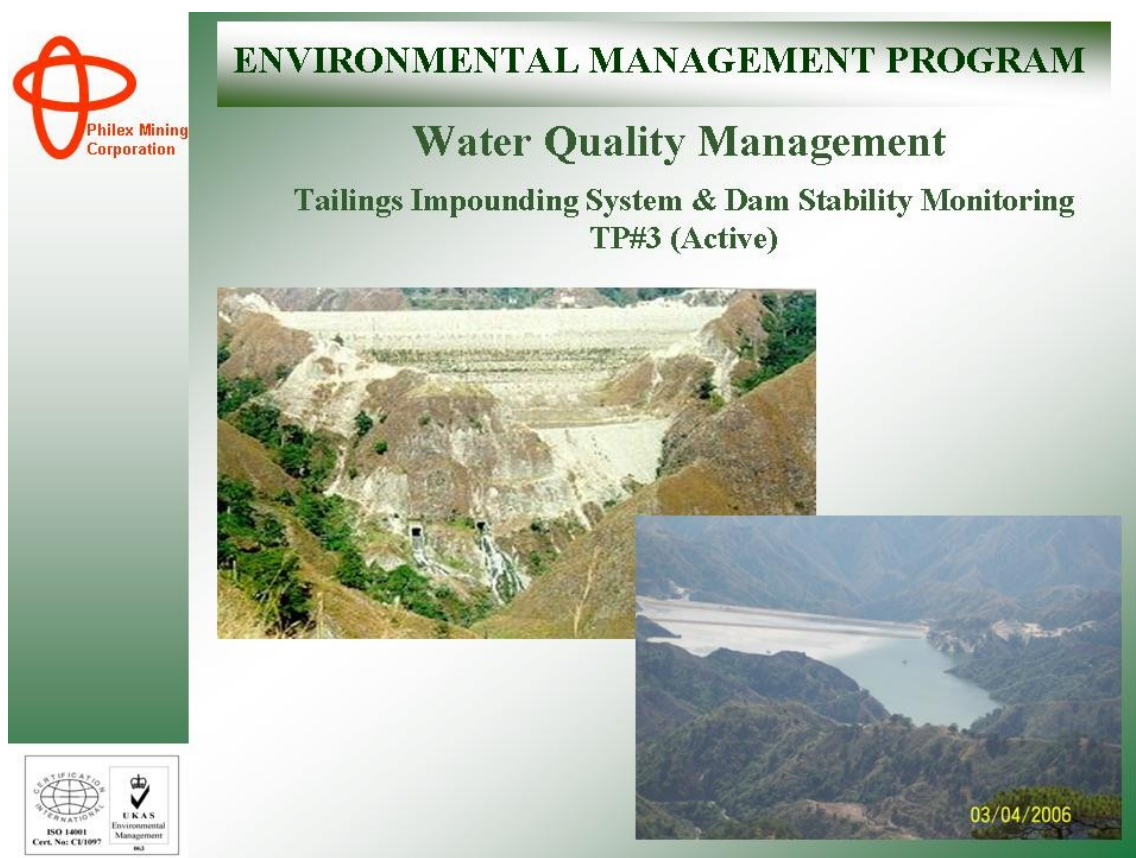
Figure 49 above depicts Philex tailings pond 3. Boquiren 2006:63 says that according to Department of Environment and Natural Resources (DENR) documents, the tailing pond has a life of 18-20 years. If we mark 1992 as the start of operation of tailings pond 3, then the tailing pond has to be decommissioned this year or 2010 or two years from now or around 2012.

Philex have not reported any additional tailings pond being constructed and its mining operations are likely to continue for at least several more years. This indicate that in a few years' time, it will be highly likely that there will direct dumping of wastes from Philex Mines into the Benguet rivers unless they cease operations.
